Mon22-072

Influence of natural hazards on the infrastructure facilities of Pokut Carpathians

**Z. V. Hostiuk (National Nature Park "Hutsulshchyna", Ukraine), O. O. Burianyk (Ivan Franko Lviv National University, Ukraine), M. M. Karabiniuk (Uzhhorod National University, Ukraine)*

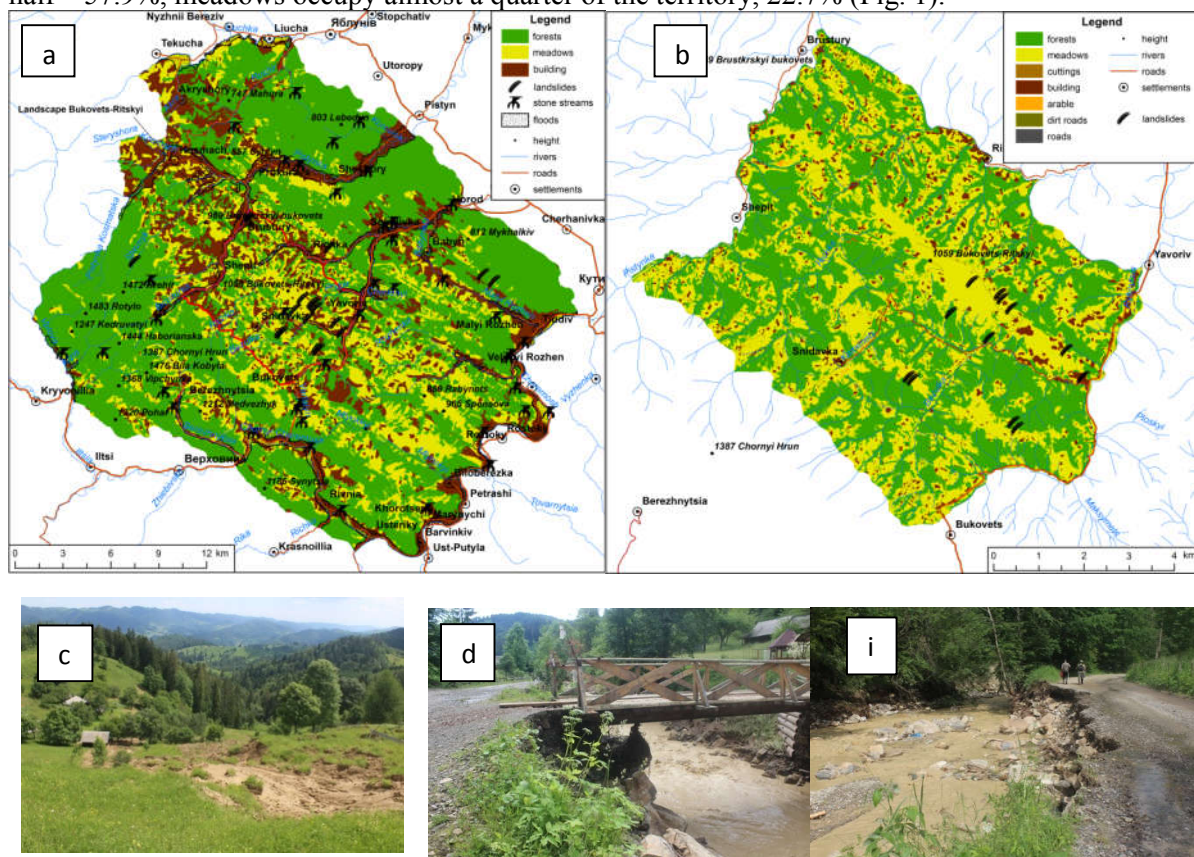
Figure 1 a) distribution of land in Pokut Carpathians, b) distribution of land in the landscape of Bukovets-Rytskyi, as well as the spatial distribution of natural dangerous physical and geographical processes, c) a landslide on Bukovets-Rytskyi ridge, d) damage to the road as a result of lateral erosion, i) destruction of the bridge as a result of the flood in June 2020

Results. After analyzing the natural features, the materials, as well as results collected during our own field research, it was found that landslides, mudslides and erosion are the most common dangerous processes in the territory of Pokut Carpathians. For the occurrence of these processes, in addition to the presence of certain geological and geomorphological features, torrential and prolonged rains, which are characteristic of the territory of Pokut Carpathians, are necessary. All these processes are extremely dangerous for the infrastructure of the region. Analyzing the spatial distribution of the structure of land plots, it was found that the studied territory is characterized by a dispersed type of development (Hostiuk, 2021), settlements are located not only in river valleys, as in most other mountain regions of Ukrainian Carpathians, but also on gentle and steep slopes, ridges that in turn, it creates a greater danger for infrastructural objects during the occurrence of physical and geographical processes. According to the results of the decoding of the satellite images, it was determined that buildings in Pokut Carpathians occupy 19.3%, almost a fifth of the territory, forests occupy more than half – 57.9%, meadows occupy almost a quarter of the territory, 22.7% (Fig. 1).

During 2020-2022, field expedition research was carried out within Pokut Carpathians and more than 15 landslides were recorded (see Fig. 1). Most of the landslides were recorded in the low-mountain part of Pokut Carpathians, somewhat less in the mid-mountain. During the research, it was found that landslides are widespread throughout the studied territory, often confined to contact structural-tectonic zones (Rudko et al., 2002; 2017), the border of Pokut Carpathians and Precarpathians, and the borders of natural territorial complexes of different taxonomic ranks (localities, strata, tracts). Landslide-hazardous areas are mostly steep areas with the distribution of clayey deposits of Carpathian flysch,

A more detailed decryption of the space images was performed on the key area of the Bukovets-Ritskyi landscape, where a few more land types were highlighted, including forests, clearings, meadows, plough lands, buildings, dirt roads, and paved roads. On its territory, almost the same area is occupied by forests and meadows – 51% and 40%, respectively (see Fig. 1) (Hostiuk, 2021). A significant area within the landscape is occupied by 6.5% of buildings, which are not confined to any part of the landscape, but are distributed almost evenly throughout the territory. About 1% of the landscape area is occupied by dirt roads and runs, and the smallest area is occupied by paved roads, 0.1% (Hostiuk, 2021). This landscape best represents the territory of Pokut Carpathians, in terms of population placement within its borders. Bukovets-Ritskyi landscape is a low-mountain part of Pokut Carpathians with the highest peak of the same name at 1059 m above sea level, represented by synclinal ridges and deep river valleys (see Fig. 1).
