## TRADITIONAL TIMBER-FRAMED CONSTRUCTION, CASE STUDY: THE RABBI FAMILY HOUSE IN KOROMĽA, SLOVAKIA

**Mgr. Volovár Maroš**

PhD graduant at Department of Theory and History of Architecture, Faculty of Architecture, Czech Technical University in Prague, Czech Republic

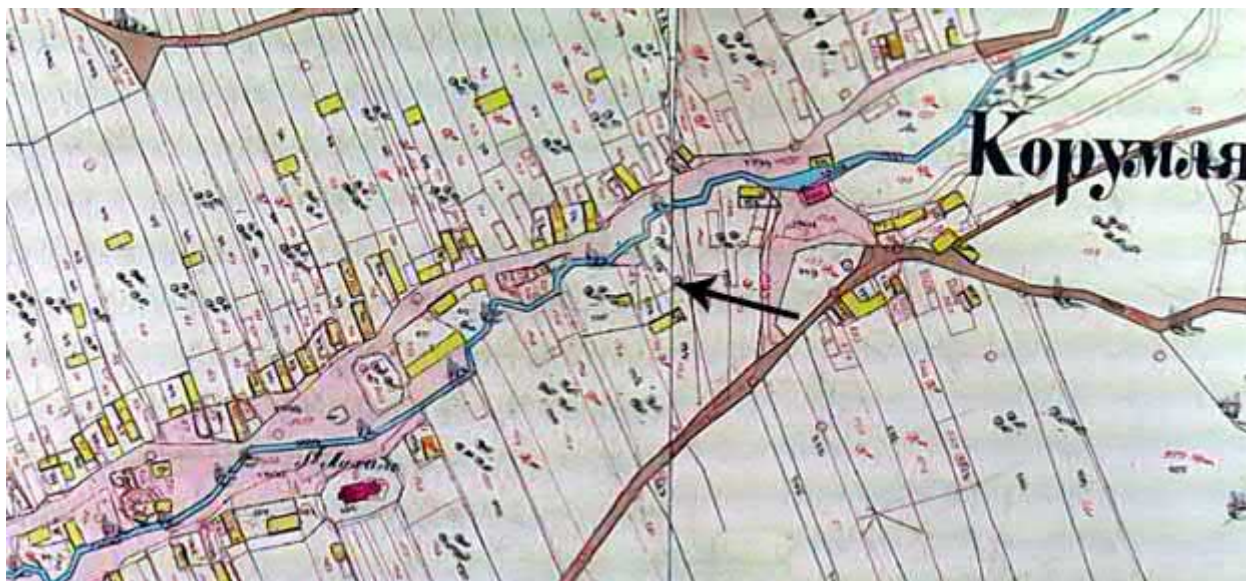
Fig. 1: Koromľa (Slovakia, Sobrance District), detail of cadastral map from 1863, updates from 1918 are marked with red line (source: Geodetic and Cartographic Institute Bratislava, add nr. Už 88).

The oldest evidence of the structural character of the village is a cadastral map from 1863, when the timber (yellow) buildings dominated here. Only the church and the mill were walled (red) (fig. 1). In 1900, according to statistics, Koromľa had 680 inhabitants, mostly Greek Catholics, 72 citizens declared the Jewish religion. The village had 91 houses, 83 of them were built of timber and 8 walled of stone or brick. All the coverings were flammable: 70 houses were covered with straw and 21 with shingles [MSK, 1902, pp. 260–261]. In 1910, Koromľa had 636 inhabitants, 78 of them declared Israeli confession. There were 106 houses, already 16 of them walled of stone or brick and 90 built of timber. 12 houses were covered with fireproof materials, 30 with shingles and 64 with straw. [MSK, 1912, pp. 260–261]. Today, the object in question is one of the last four timber houses remaining in the village, the youngest one (Nr. 157) was built cca in 1936.

On the sketch to the cadastral map from 1863, there is no regular development in its vicinity and the house is still not recorded. The clean copy of the map contains updates marked with a red line in 1918, when the boundaries of the plots were adjusted to today's shape and the house with current Nr. 114 appears (fig. 1). Building of the house between 1863 – 1918, according to the maps, was confirmed by dendrochronological research, which proved that the structural elements are made of oak wood cut at the turn of 1890/91 and 1891/92 and so the house, usually carved from fresh wood, was probably built in the years 1891 – 1892. Dendrochronological research was realised by Ing. Tomáš Kyncl on the 31/7/2019.

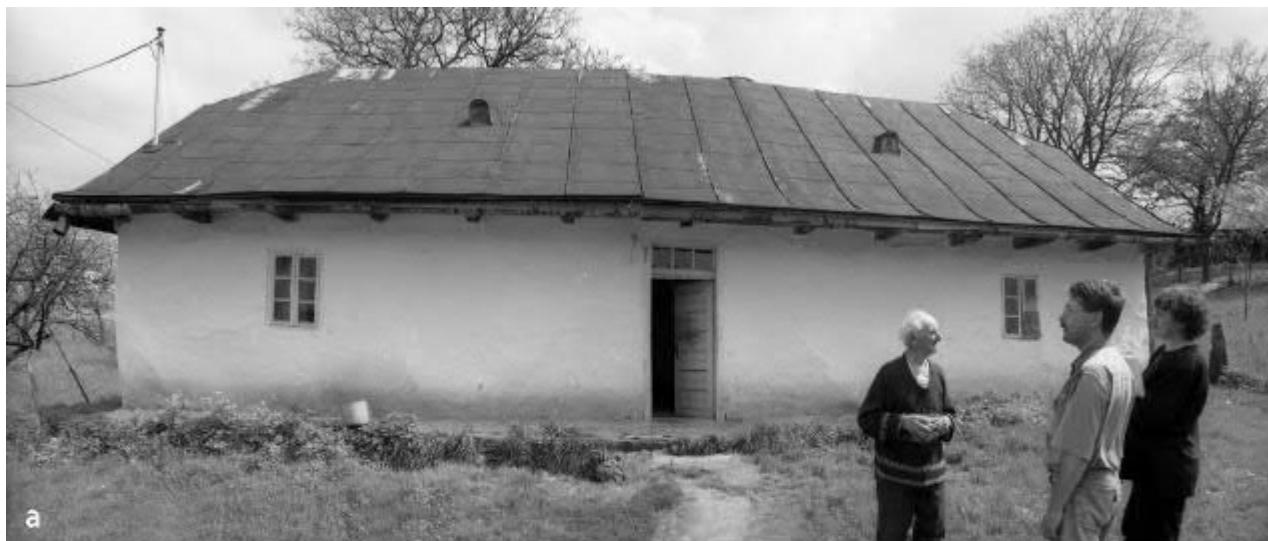
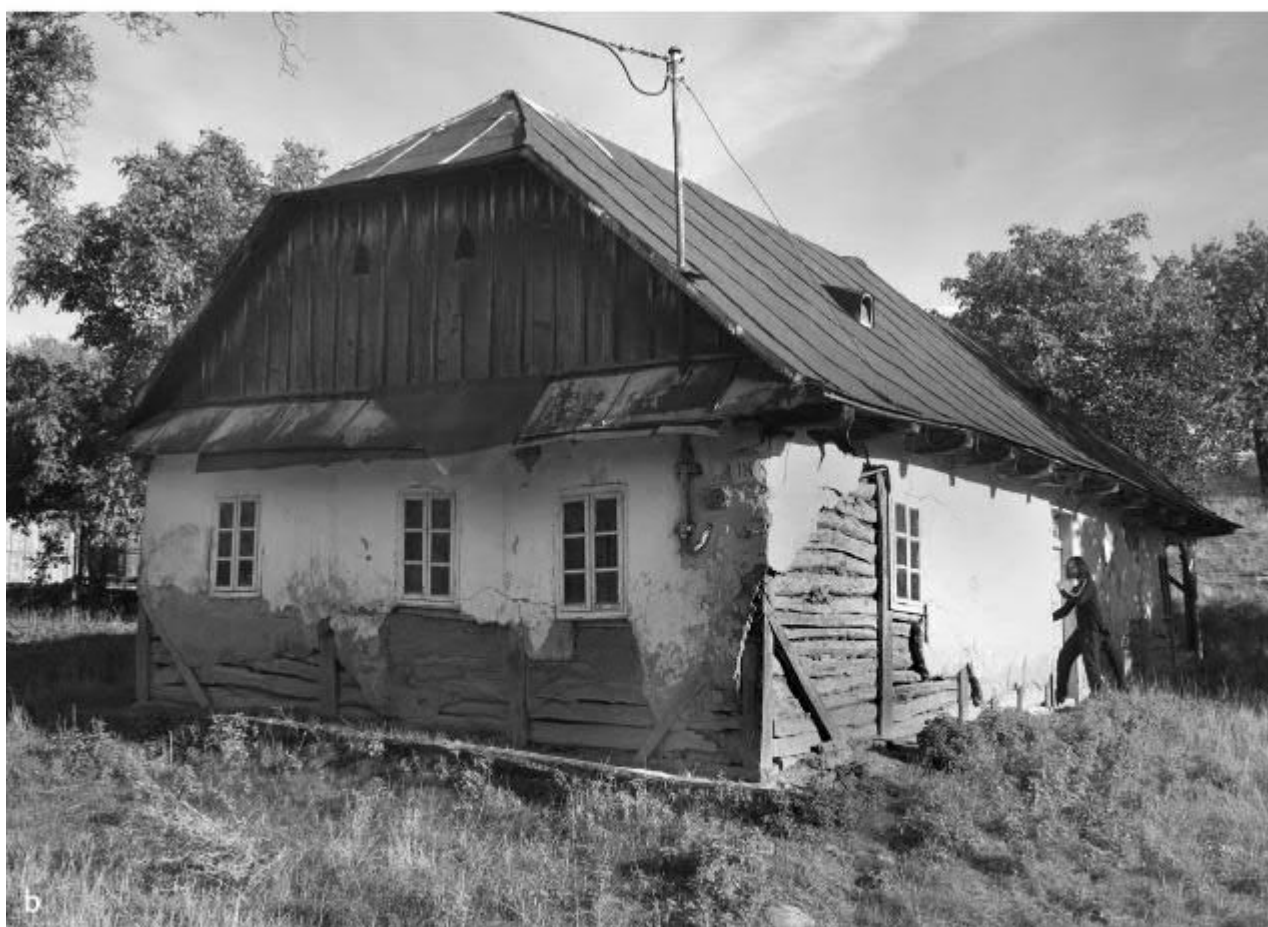
Fig. 4: Koromľa (Slovakia, Sobrance District), Nr. 114: **a** – Court facade in 1997. With his back to the house stands the last inhabitant Adolf “Abram” Gubner (photo by V. Sinčáková, 1997); **b** – North east corner of the house facing the street (photo by M. Volovár, 2013).

The house stands in a left-bank side, above the centre of the village at a height of 290 m above sea. It faces the shorter, north side towards the street (fig. 2a, 4b). The house is cca 7.5 m wide and 15.3 m long, ground, without a basement, the roof has upper third-hipped gables (fig. 2).

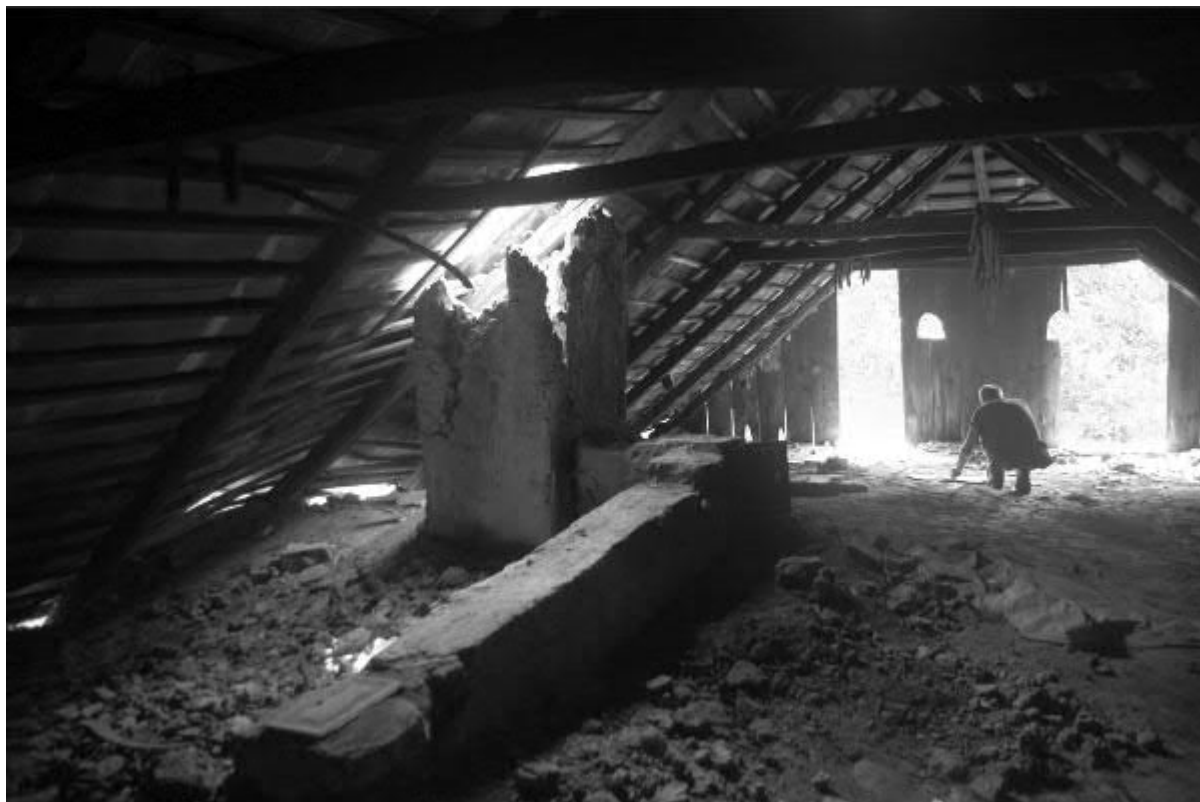
Fig. 5: Koromľa (Slovakia, Sobrance District), Nr. 114, the loft with the smoke shaft and chimney (photo by M. Volovár 2018).

Four rooms of the house were heated. In the front room of the front bay, a rectangular metal sheet on the floor and a smoke opening in the eastern corner indicates the unpreserved oven or stove, mouthed across the partition wall into adobe chimney in the western corner of the kitchen (fig. 6). On the loft, it is fed to the main wide chimney above the south wall of the kitchen (fig. 5). Latter is also built of adobe, only an unpreserved section above the covering was made of brick. In the kitchen, the stove was walled left to the main chimney. The bread and maces oven was walled in the rear room of the rear bay and mouthed also across the partition wall into the chimney, stoked from the kitchen through the chimney base. The front room of the rear bay could have a cast-iron stove, mouthed across the two partition walls into the same chimney in the kitchen.

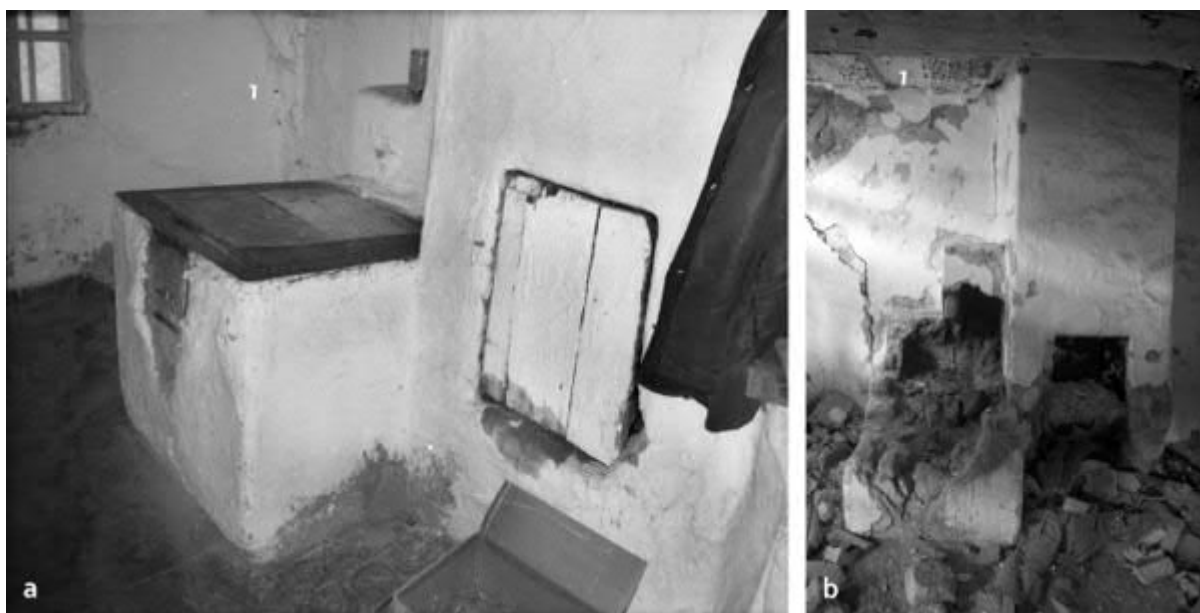
Fig. 6: Koromľa (Slovakia, Sobrance District), Nr. 114, walled stove and chimney in the kitchen: **a** – State in 1997 (photo by V. Sinčáková); **b** – State in 2018 (photo by M. Volovár).
